# Manhole Inspection Summary

Manhole # S57A\_\_021MH

**Inspection** ☐ Is Incomplete Rating: **3) Fair**

**Location** Address: **400 haven st**

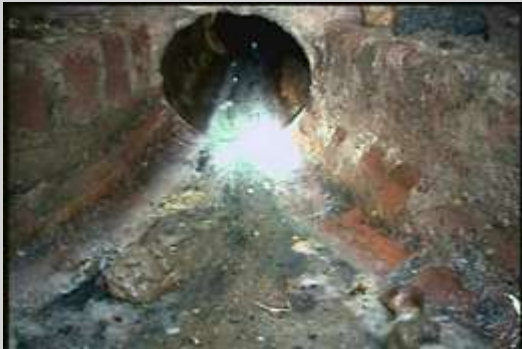
12 O'Clock Outflow

8 in. Circular Gravity Sewer  
Pipe Out @ 12 O'Clock

Pipe Material: **Clay** ☐ Pipe Lined

Invert Depth: **9.24** (ft.) Flow Characteristics: **Slow**

Deposits: ☒ None ☐ Mud ☐ Sludge ☐ Debris ☐ Grease

Infiltration: **None** Pipe Seal Cond: **Unknown**

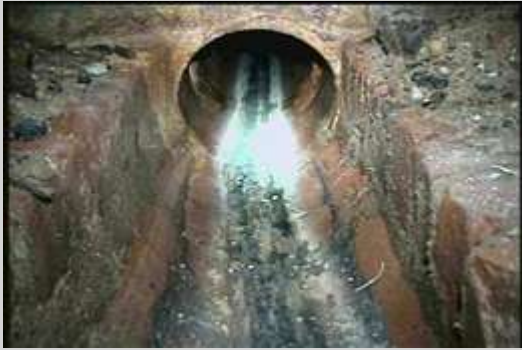
6 O'Clock Inflow

8 in. Circular Gravity Sewer

Pipe In @ 6 O'Clock

Pipe Material: **Clay** ☐ Pipe Lined

Infiltration: **None** Pipe Seal Cond: **Unknown**
